Experiences, associated capabilities and responsibilities of Landfill Management in Kampala Capital City authority Uganda.

Madinah Nabukeera

Islamic University in Uganda Females' Campus

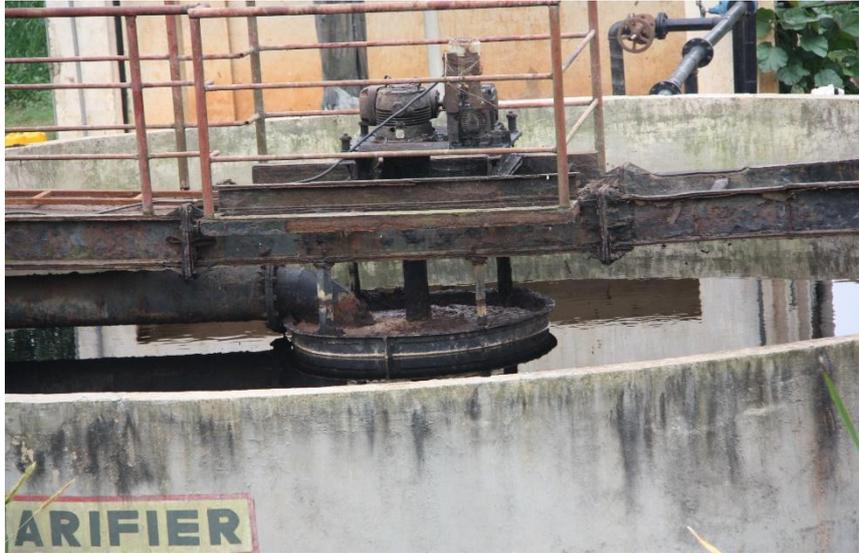
Figure: 1 Clarifier center support photo taken on 30th Nov. 2013.

In spite of the modest achievements of KCCA, there is need for urgent additional works on the leachate treatment plant, to replace the items that are beyond maintenance after being in operation for over seven years i.e., ; (i) clarifier walkways and (ii) clarifier center support.

The corroded Clarifier support and walkways

Repairs at the Clarifier should be given top priority, the deformed beams have compromised the alignment of the gear boxes and scrappers causing frequent break downs. It should be noted that the clarifier effluent is very poor whenever the clarifier is not working.

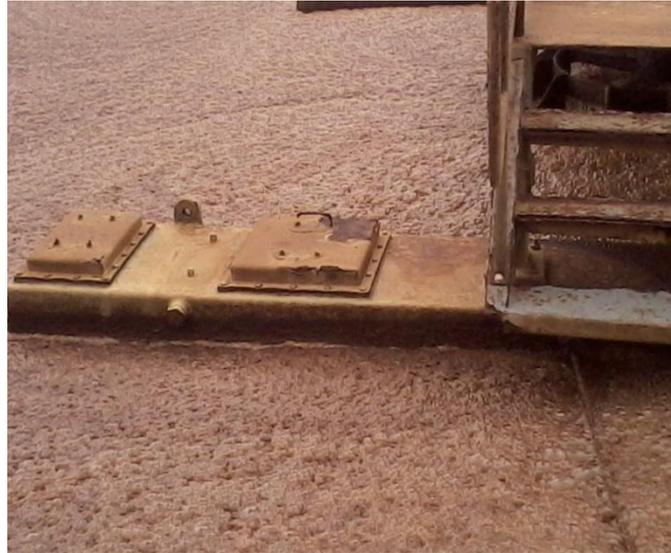
Figure: 3 Corroding floater and stairs for Aerator C

Finally, there is need to replace the epoxy (fiberglass) coating insulation layer on the Aerators in order to extend their life especially Aerator C “see **figure 3** below”, (one near the clarifier). This coating is broken in some places for all the three Aerators causing corrosion as shown in the pictures below. Aerator C could sink if this is not done early enough because there is already corrosion on one of its floaters.

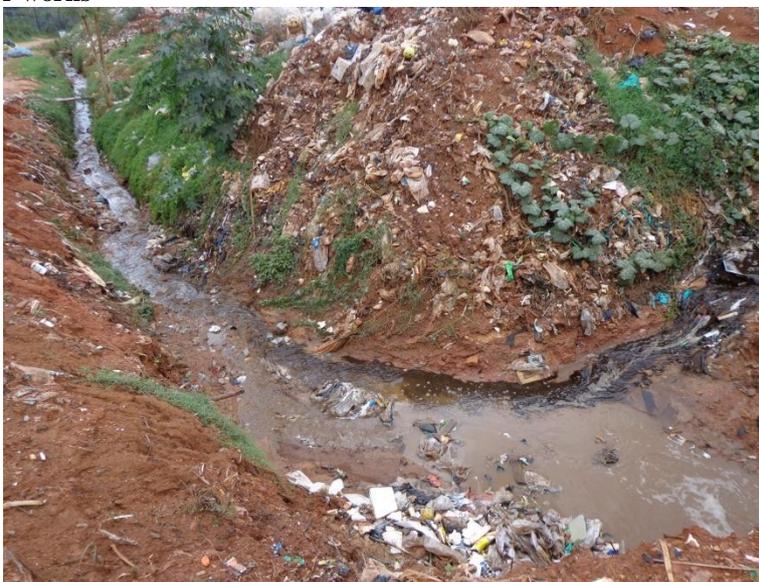
Figure: 5 Unobstructed Leachate flow as well as stormwater at the Leachate Collection Sump - September 2013

All Leachate from the Landfill has continued to flow unobstructed from all sides of the Landfill after construction and upgrading as well as maintaining the Landfill drains during September 2013. Unfortunately, September 2013 was extremely heavily wet and all storm water from upstream ended up in the Leachate Collection Sump, silting it up.

To divert all storm water away from Leachate for enhanced treatment by the Leachate Treatment Plant. During October 2013, the Landfill Team made a diversion of the storm water off the Eastern side of the Landfill i.e., from Buwambo Road, through landfill office road down to the wetland downstream. Recommendation is for works at the extension should also include diversion of storm water from the upper catchments to separate it from storm water of the western side of the Landfill from Leachate as well. A follow up independent check on the chemical composition of the leachate to check on the monthly performance by Directorate of Government Analytical Laboratory – Ministry of Internal Affairs. However, this was not possible during last year due to budgetary constraints. The Landfill Work-force of Kampala Capital City Authority in July 2013 initiated monthly comprehensive investigations on Leachate, Catchment Surface and Ground Water. Monitoring regular Landfill Leachate Treatment Plant Performance is way forward for KCCA.

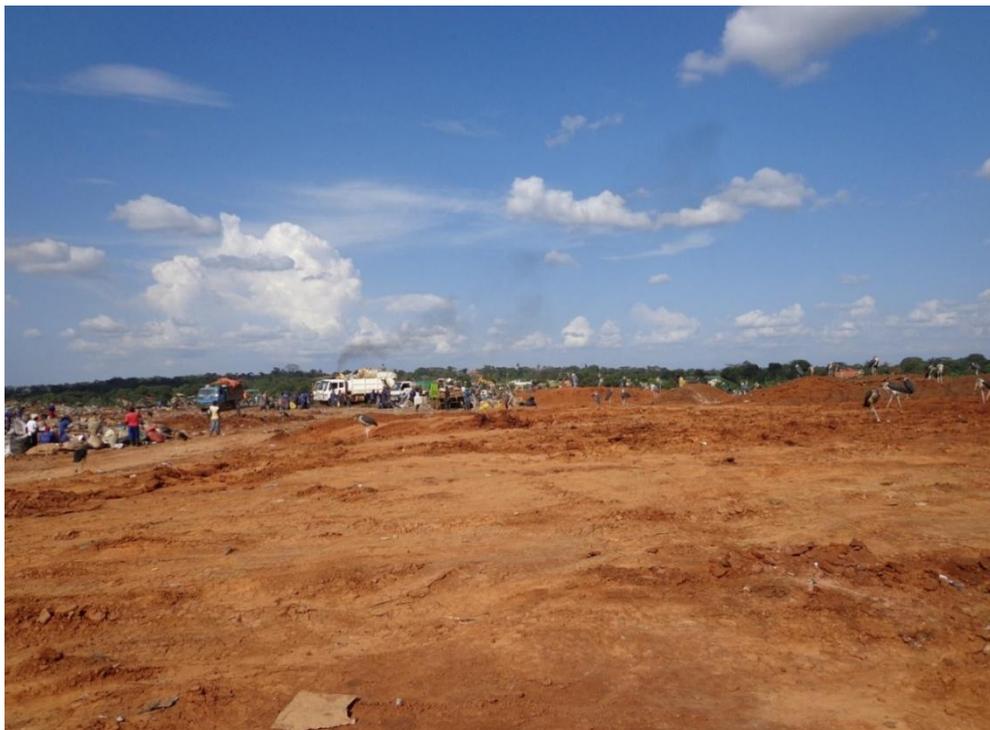
Figure:6 Animator – D-85 handling Landfill activities swiftly. Dozing waste at the North-Eastern Tipping Fronts after dozing marrum at the South-Eastern Tipping Front September 2013

The September weather was extremely wet with heavy erratic rain-spells. However, these were interrupted by hot sunny days softening the working environment at the Landfill. The conditions generally were a platform to tease Landfill Work-force's ability to perform during extreme and unpredictable weather conditions and in the erratic weather conditions they managed to develop the Southern & South-Eastern tipping fronts by the end of September 2013 i.e., (i) South-Eastern tipping front had been successfully extended, (ii) Southern tipping front had been successfully extended, and (iii) soft areas within Southern tipping front relatively reinforced. The two tipping Fronts – Southern and South-Eastern were planned tipping areas for the month of October- December 2013, as Landscaping for developing further North-Eastern access road and accompanied radiations were being undertaken. The constructions refined the advance of Mpererwe Landfill and it was a respite that garbage trucks can swiftly deposit garbage at the planned tipping fronts for eventual handling by the landfill workforce.
